Winnepesaukee Yacht Club

State of the Foundation Address
July 2, 2010

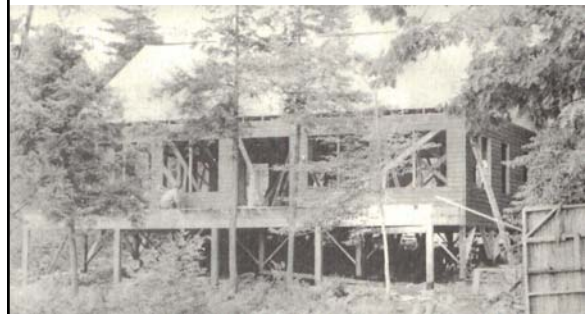
1948 Club House under construction on wooden piers

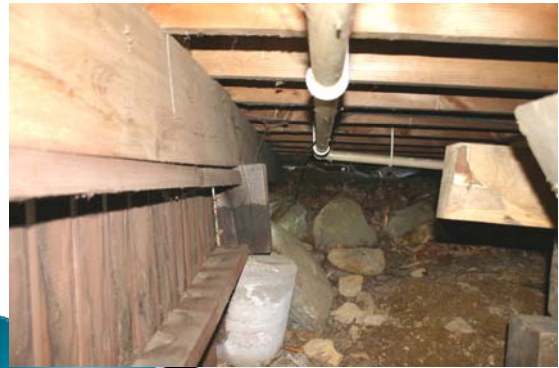
- ▶ Failing foundation and sub-floor structures
 - Failed and Rotating piers along the Kitchen Wall
 - Inadequate footings and lateral bracing throughout the structure
 - Shifted Concrete Footings
 - Floating Piers
 - Sunken Footings causing building shift
 - Rotting and Cracked Sills
 - Kitchen outside walls
 - Cracked Sill under main door

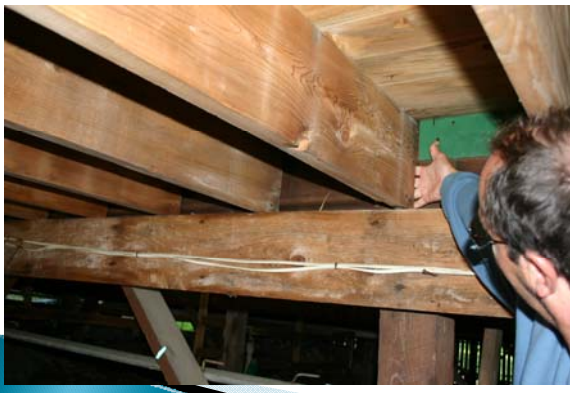
Kitchen Addition Shift

- ▶ Water problems
 - Free flow from parking lot
 - Freeze/Thaw causes moving pilings
- ▶ Kitchen addition moving away from the main building
 - Steel beam short term solution
- ▶ Upper Framing questionable for snow and wind loads
- ▶ Will worsen with time
 - Safety!
 - Clubhouse in jeopardy
